**R467 REGIONAL ROAD, OLOVO-HAN PIJESAK SECTION
ROADBED REPAIR
SANACIJA TRUPA REGIONALNE CESTE R467 DIONICA
OLOVO-HAN PIJESAK**

Mirza Memić, Radomir Folić, Edis Softić
JU Direkcija regionalnih cesta TK, A. Herljevića 43 Tuzla, mirza.memic@bih.net.ba
University of Novi Sad, Faculty of Technical Sciences, Serbia, folic@uns.ac.rs
Univerzitet u Bihaću, Tehnički fakultet, Irfana Ljubijankića bb, edis.softic@bih.net.ba

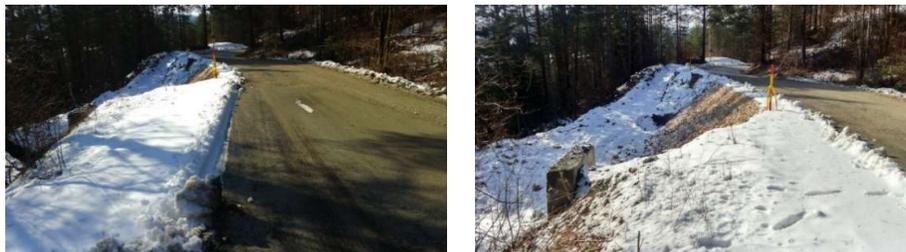
Figure 1: Photographs from the spot

After the natural disaster of extreme rainfall in the area of Zeničko-Dobojski canton in 2014, a large number of landslides emerged. In such circumstances, there was a loss of stability of a part of the slope and of the existing road structure of the R 467 regional road, Olovo-Han Pijesak section, at the chainage 1+200, figure 1. For the purpose of obtaining relevant data for the landslide remediation, detailed geodetic surveys, engineering-geological and geomechanical test were conducted, which provided the following data:

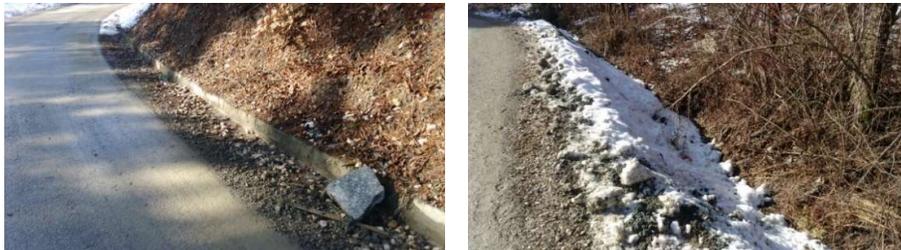
Figure 2: Photographs from the field – the existing gutter and ground ditch on the uphill side

The surveying revealed that one of the basic causes for instability of the slope is the impact of the uncontrolled influx of surface waters flowing in from the hill side, down the road. There was a partial or complete congestion of the existing drainage system (asphalt gutter, ground ditch and concrete pipe culvert, figure 2) which led to the ground water level surge, and to increasing pressures and loads on the road and embankment structure. In such cases, the characteristics of the clayey materials in the road base, slopes of the embankment and the contact layer with the substrate. The consequence of that is probably the emergence of land sliding on the downhill side of the road and the loss of structural

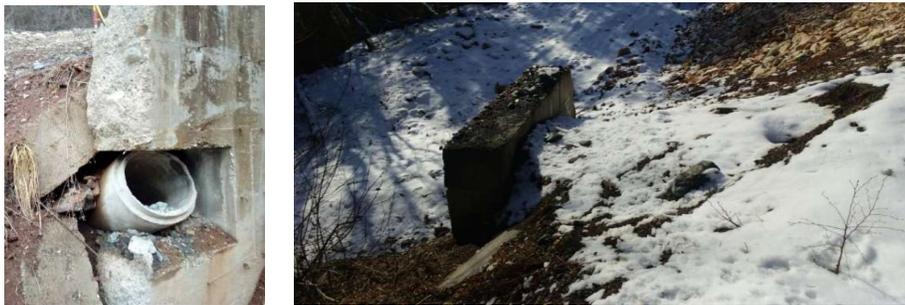
Figure 3: Field photographs—the existing culvert and outlet structure on the downhill side

stability with considerable damage of the existing culvert and outlet structure, figure 3. On the uphill side of the road, no land deformation was observed. A temporary repair was an intervention comprising filling in using the stone material.

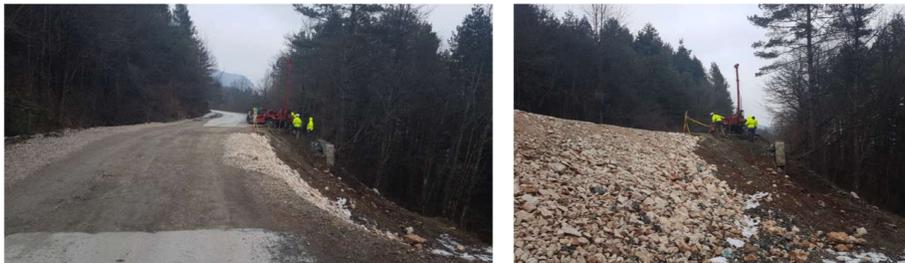
Figure 4: Exploratory excavations

For the purpose of establishing engineering-geological conditions on the spot and of geomechanical properties of soil, two exploratory bores were made, figure 4. The exploratory works at the depth of 4.5-6.0m revealed the marlstone. During the exploratory works, no groundwater was encountered, [8]. Based on the previously described engineering-geological terrain characteristics and on the comparison of laboratory results conducted during these researches, comparison and experience with the similar materials, a geotechnical profile of the terrain with the calculation parameters is adopted, figure 5. The

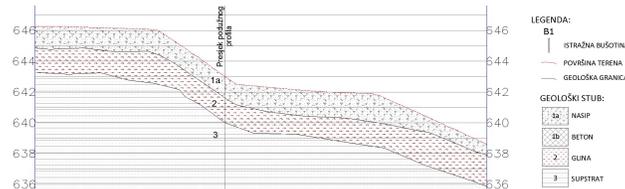
Figure 5: Engineering-geological terrain profile, [8]

Mirza Memić, Radomir Folić, Edis Softić-R467 regional road, Olovo-H. Pijesak section roadbed repair parameters of physical-mechanical characteristics of the rock mass are obtained using the Hoek-Brown criterion of intact rock strength, [8].

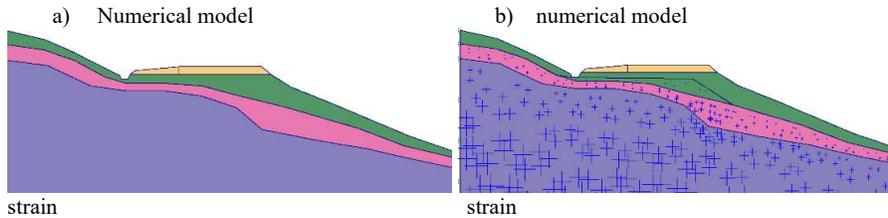
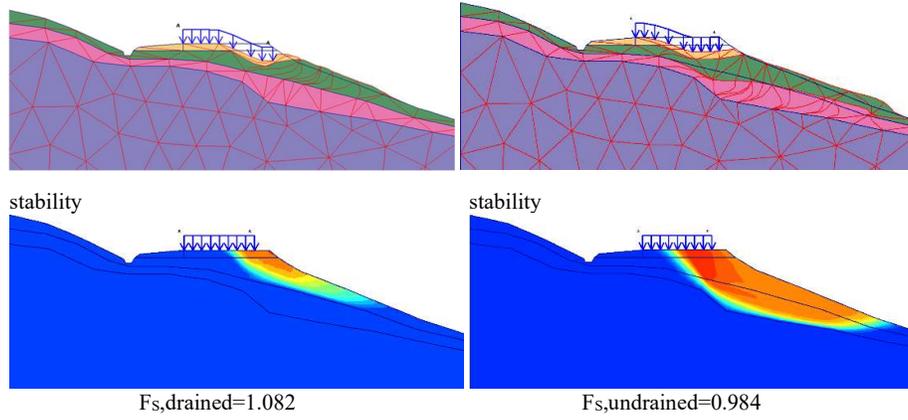
Figure 6: Numerical models – current status a) drained, b) after water action

After making of the numerical model, an initial calculation of the current status is performed. Considering the obtained safety factor, it is concluded that the existing structure is stable in the drained conditions, figure 6, a). Let us mention that after the exploratory works it was assumed that the cause of landslide occurrence is the uncontrolled influx of water into the roadbed. When in the numerical model the action of ground water is simulated, it causes the reduction of the safety factor and the loss of stability of the existing structure, $F_s, \text{undrained}=0.984$, which confirms the assumption, figure 6, b).

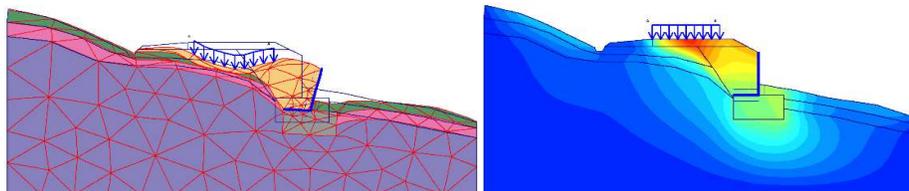
Figure 8: Numerical model: a) strain b) $F_s=1,287$

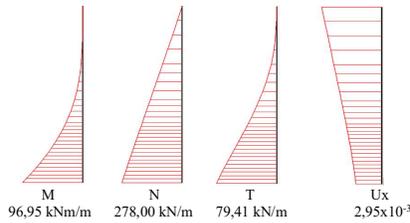
Figure 9: Static effects in the RC wall
